Stress corrosion cracking in AA5083 mold material used for curing rubber compounds

A. Alkan¹, S. Gümüş¹, Ü Atapek¹, Ü Polat¹

¹Kocaeli University, Metallurgical & Materials Engineering, Kocaeli, Turkey

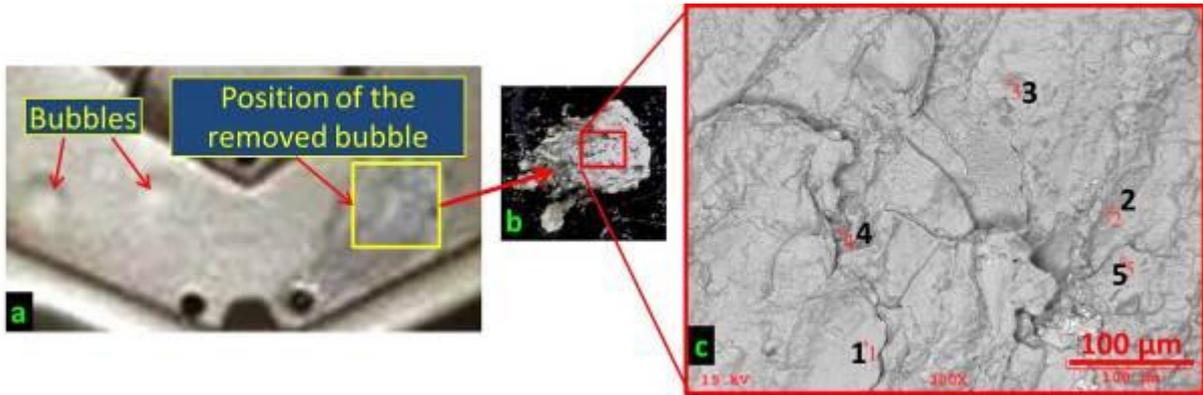
In this study, the failure analysis of AA5083 mold material, used for curing rubber compounds, was carried out. The problem revealed itself as the formation of bubbles, 4-6 mm in diameter, on the mold surface during curing process and caused quality problems in the final product (Figure 1a). In the first stage of the analysis, elemental distribution maps were taken by energy dispersive x-ray spectrometer (EDS) from the interior part of a bubble (Figure 1b) and accumulation of both Mg and also Cl was observed (Figure 1c, Table 1). In the second stage, two samples 10-25 mm in width were taken out from the mold material. The first sample was very close to outer part of the mold and had no contact with the rubber compound. The second sample was taken from the inner part of the mold, 5 mm in depth from the surface. The samples were embedded in resin and polished surfaces were examined using scanning electron microscope (SEM) and EDS.

Figure 1. Analysis of a bubble taken from the mold surface; (a) position of the removed bubble, (b) interior part of the removed bubble; (c) points where the spot analyses were carried out.

Spot	Element (count-%)										
	C	O	Mg	Al	Si	P	S	Cl	Ti	Mn	Fe
1	0.171	6.882	4.576	86.910	0.101	-	-	0.608	0.266	0.451	0.035
2	0.123	17.685	7.121	72.026	0.040	0.163	0.015	2.120	0.101	0.489	0.117
3	0.0037	25.904	11.761	60.129	0.040	0.255	-	1.362	0.064	0.344	0.104
4	0.028	42.319	26.048	29.842	0.237	-	0.010	1.182	0.053	0.245	0.037
5	0.618	9.557	4.318	84.391	0.028	0.223	0.019	0.493	0.052	0.257	0.042

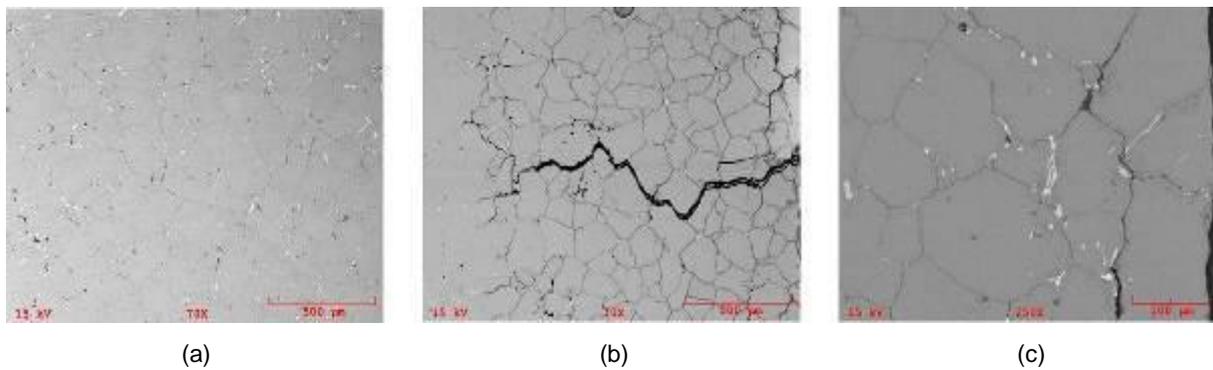
It was concluded that (i) the contamination by Cl ions was due to the cutting oil used to open vent holes during mold cleaning, (ii) the outer part of mold material had finer α -Al grains whereas the inner part in contact with the compound had coarse grains due to the thermal effect of curing process (Figure 2a and b), (iii) β -phase (Al_3Mg_2) formed at the grain boundaries after a sufficient exposure to temperatures above 50 °C (Figure 2c), (iv) the grain boundaries had Mg-rich phase showing anodic behavior, while the grains had Al-rich phase showing cathodic behavior, (v) the cracks initiated and propagated through the grain boundaries as stress corrosion cracking which resulted in the separation of grains and the accumulation of gases appeared as bubbles due to thermo-mechanical aging and effects of corrosive medium.

Figure 2. The variation of α -Al grain size in the outer (a) and inner part of mold material (b), Mg-rich phases visible in light contrast at the grain boundaries (c).
