## MS.6.P173

### The SEM study of cavitation damage of as-cast ductile iron

O. Eric Cekic<sup>1</sup>, M. Dojcinovic<sup>2</sup>, S. Balos<sup>3</sup>, D. Rajnovic<sup>3</sup>, L. Sidjanin<sup>3</sup>

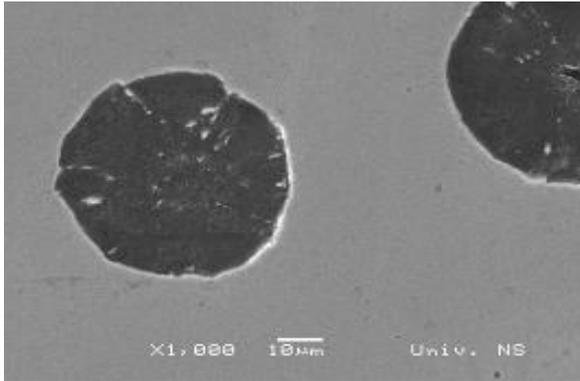
**Figure 1.** Erosion of graphite nodules

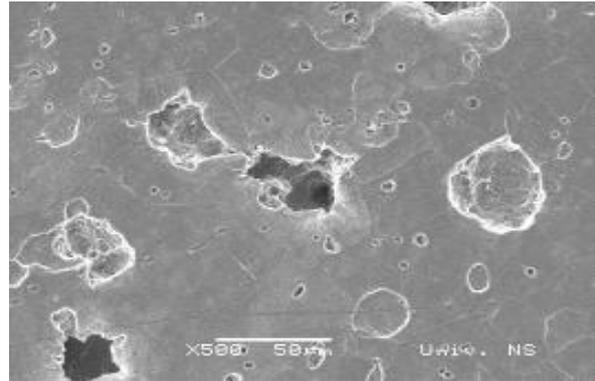
**Figure 2.** Pits produced by graphite nodule removal 30 min cavitation time

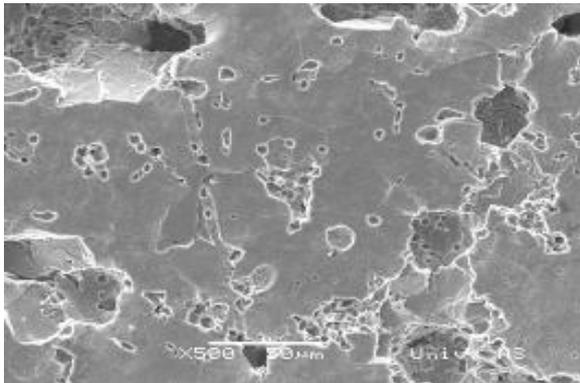
**Figure 3.** Formation of microcracks by coalescence of pits, 60 min cavitation time

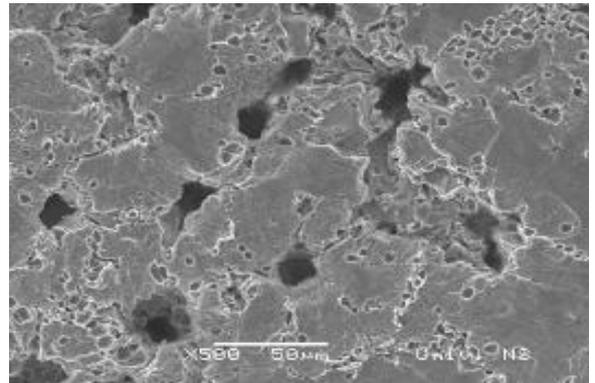
**Figure 4.** Groves and microvoids forming along the phase boundaries, 120 min cavitation time

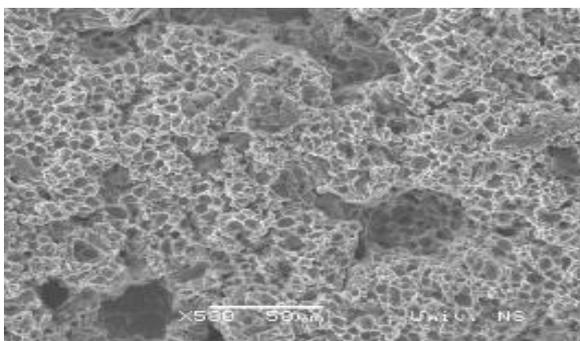
**Figure 5.** The eroded surface 240 min cavitation time
